USAAEFA PROJECT NO. 80-07

CLIMATIC LABORATORY SURVEY HUGHES YAH-64 HELICOPTER

FINAL REPORT

MARCH 1982

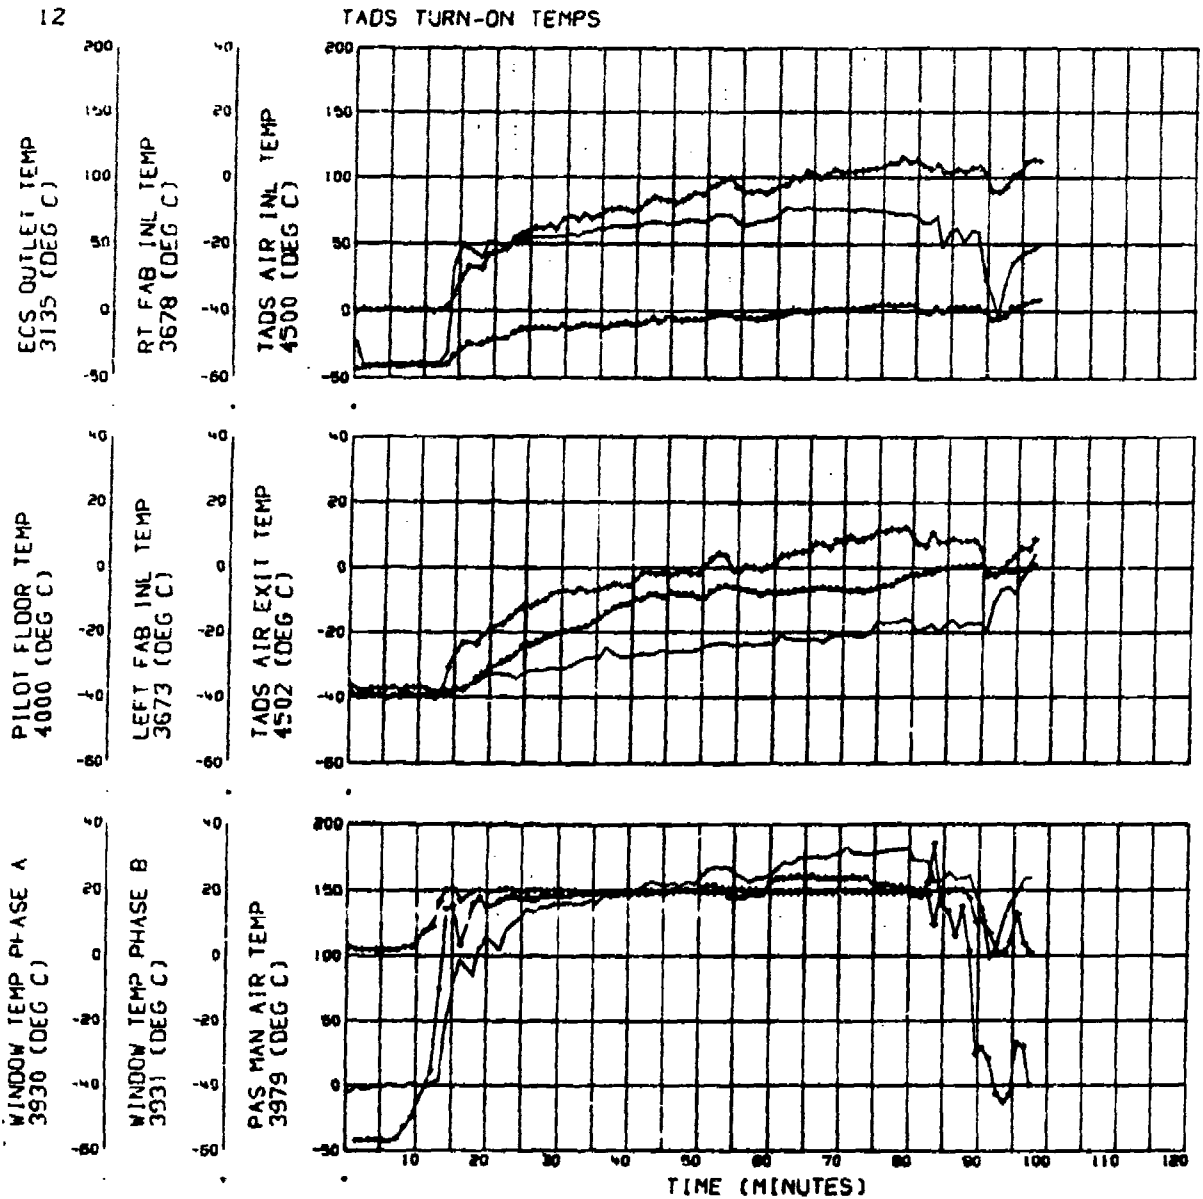
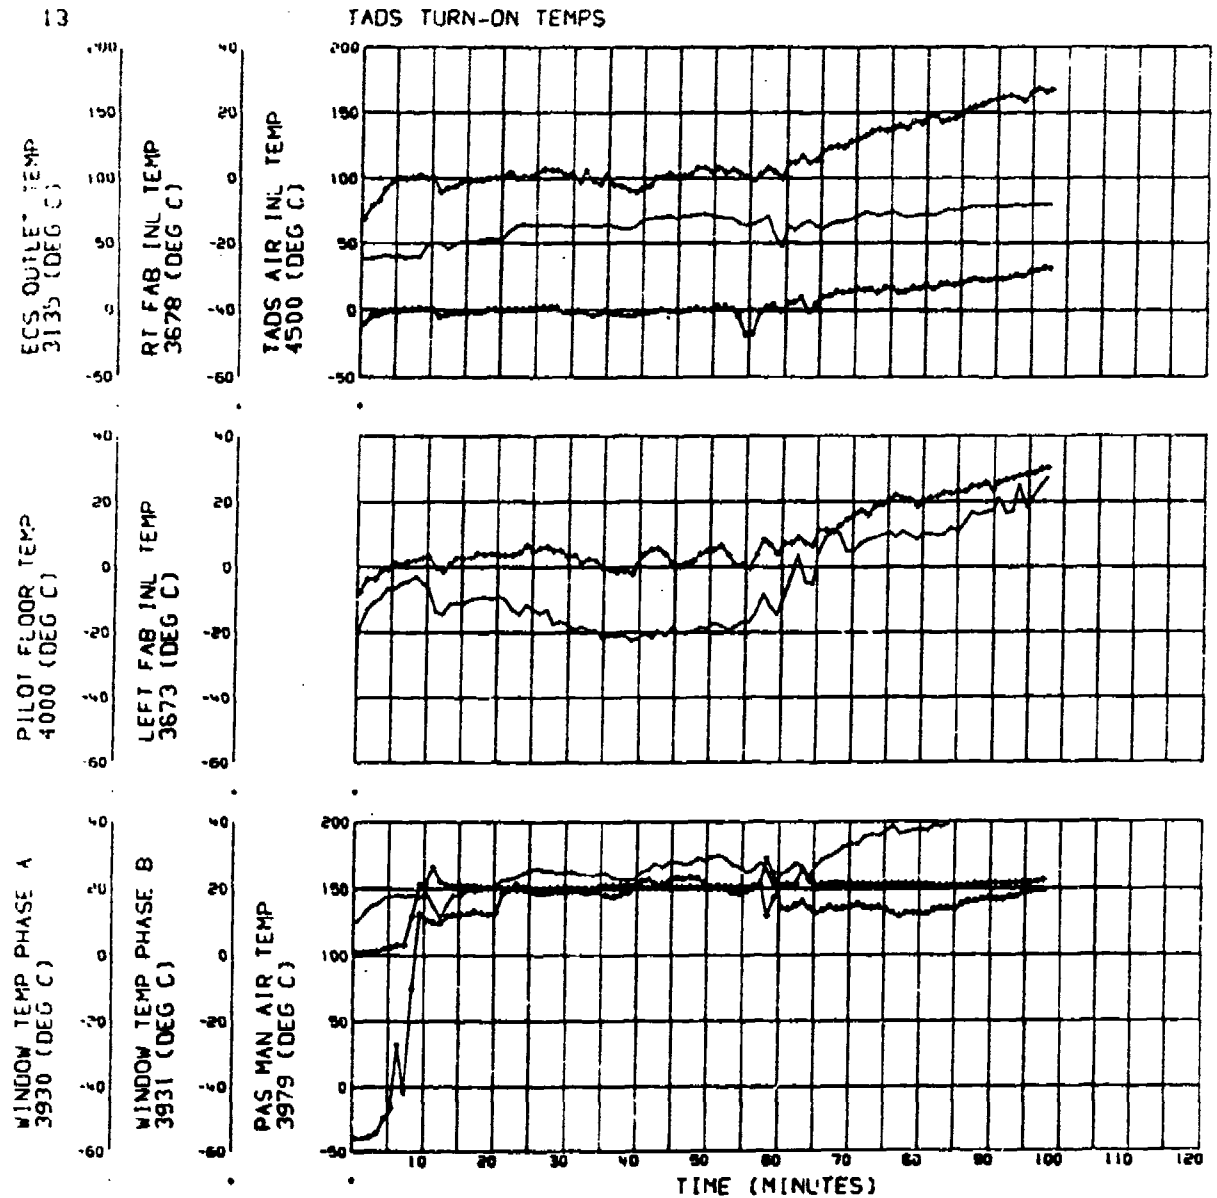
Figure 3-3
Mission Equipment Air Temperature Survey
YAH-64 USA SN 74-22249
Climatic Laboratory Temperature (-50° F)

b. TADS air inlet temperature data is summarized in Incl 3, table 3-3, and also presented in Incl 3, figure 3-3. Two -50°F (-45.6°C) test runs were available for TADS operation: (1) During the first run, the minimum ECS run time was started at a TADS inlet temperature of 0°F (-17.7°C) which allows a minimum run time of 60 minutes prior to turning the TADS on. As the aircraft ENCU continued to provide warmer air, the time lapse precluded using any other minimum run time. After 42 minutes into the test run, the TADS inlet temperature was -4°C. When 60 minutes had been reached, the 40°F temperature had not been provided by the ENCU, the symbol generator had not provided symbology, the aircraft portion of the test had been concluded; therefore, the TADS was not turned on and the test was terminated. (2) The second run was conducted with the fire control computer and symbol generator preheated. After the minimum time had been reached and the TADS was switched out of standby the TADS 28 VDC circuit breaker tripped and the system was turned off and the test was terminated.
